Fire Alarm
Annual Inspection Report
Service Date: 3/27/2025

Dunes Of Panama / BLDG A
7205 Thomas Dr.
Panama City Beach, FL 32408

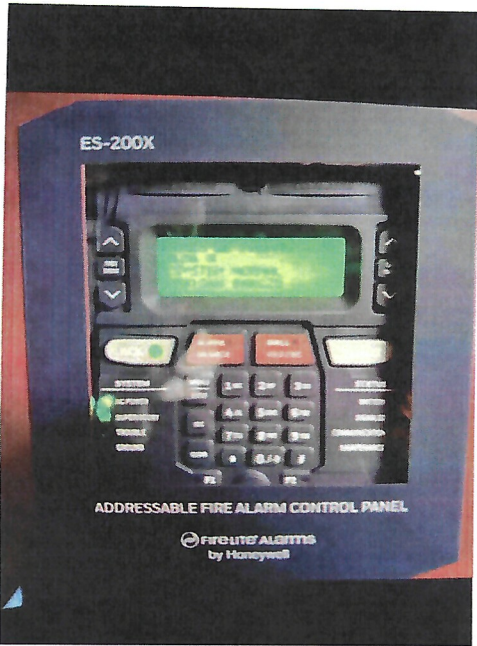
3. FACP UPON ARRIVAL

1. FACP WAS SYSTEM ALL NORMAL UPON ARRIVAL. (SEE EXHIBIT 3.)
3. BOTH FACP BATTERIES PASSED LOAD TESTING (SEE EXHIBIT 4 & 5)
4. ALL COMMUNICATION SIGNALS WERE VERIFIED THROUGH THE MONITORING AGENCY.
5. THE PANEL WAS RETURNED TO NORMAL AND TAGGED UPON COMPLETION OF INSPECTION AND TESTING. (SEE EXHIBIT 6)

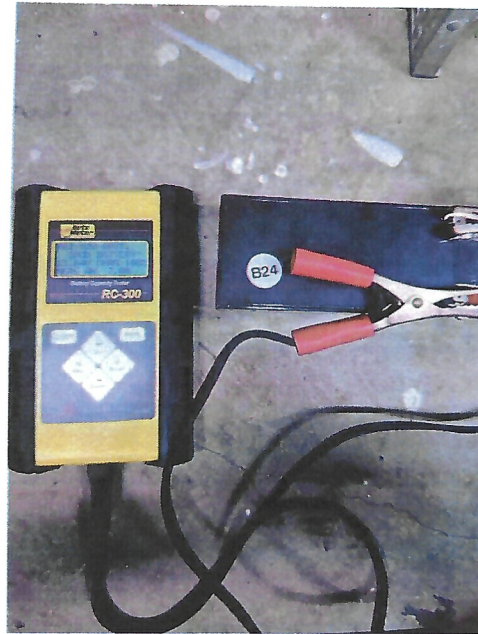
4. FACP BATT#1(02/2024)GOOD

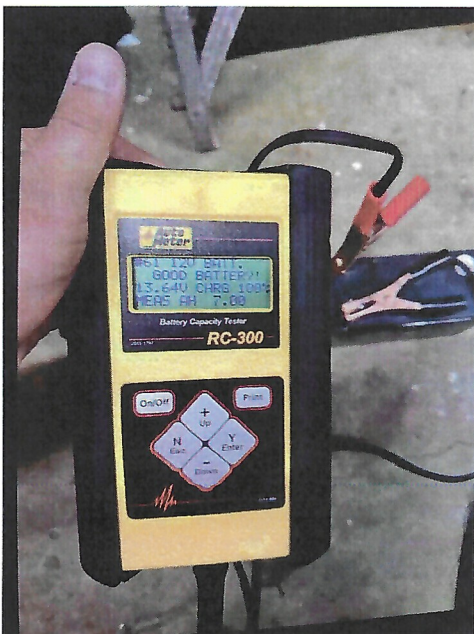
5. FACP BATT#2(02/2024)GOOD

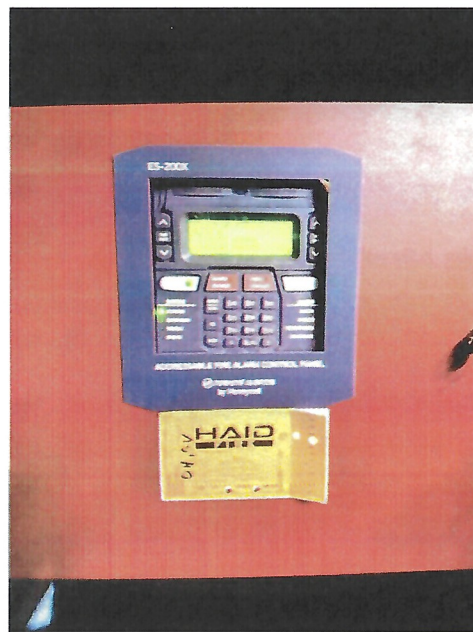
6. FACP UPON COMPLETION
